Rundschreiben: Gruppe: Getriebe: No. 3 - 15.08.1942

Betr.: Getriebe BMW R20 und R23

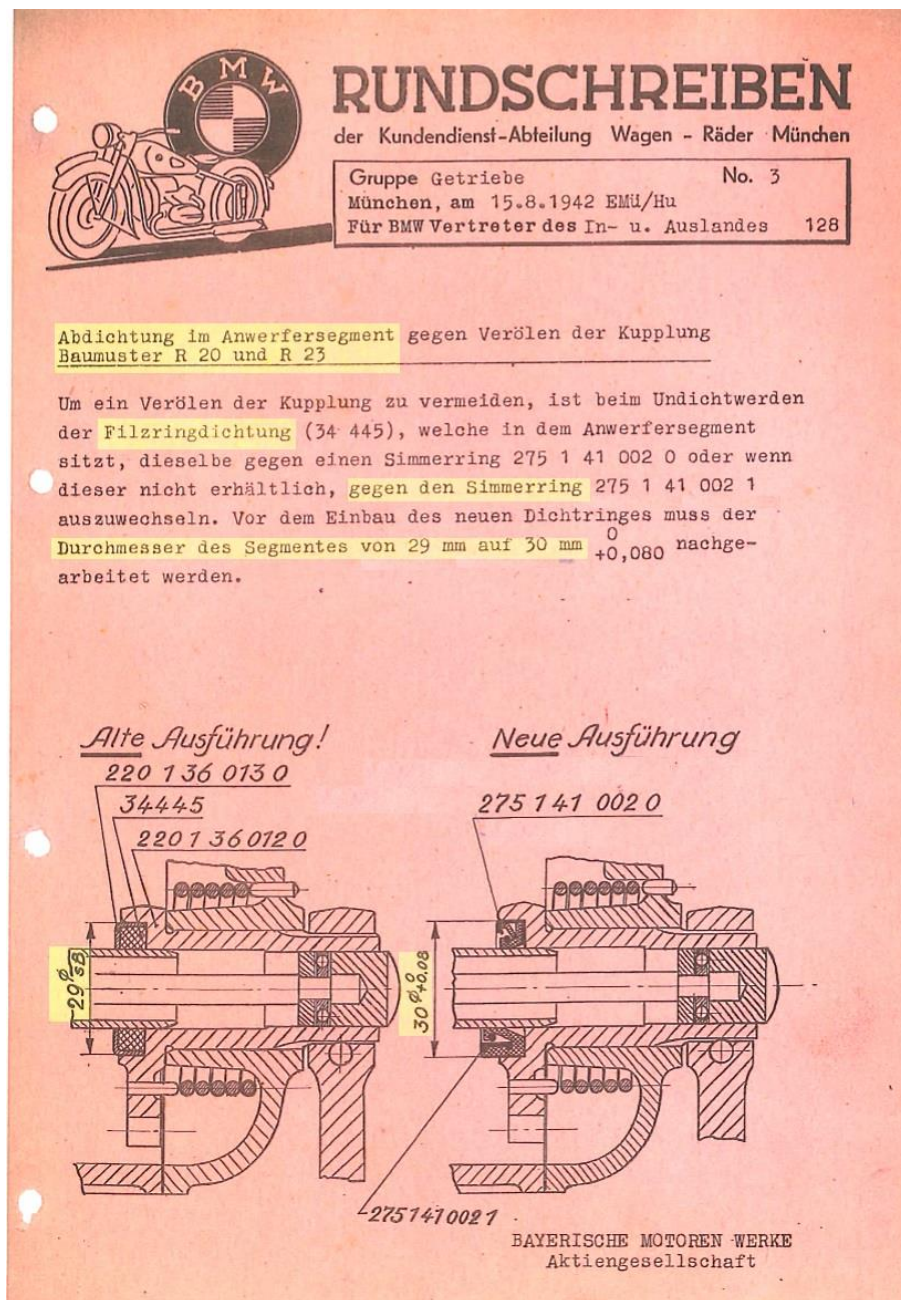
Da bei diesen Modellen Öl durch einen undichten Filzring in die Kupplung gelangen konnte, sollte der Filzring gegen einen Simmerring ausgetauscht werden.

Da die Bohrung für den Filzring jedoch nur 29 mm betrug, musste das Gehäuse auf 30 mm erweitert werden. Wie das geschehen sollte, wird nicht erwähnt und wird auch nicht so einfach zu bewerkstelligen gewesen sein.

Es standen zwei Simmerringe zur Auswahl, die sich nur in ihrer Breite unterschieden, ansonsten jedoch im Innen- und Außendurchmesser gleich waren.
