Rundschreiben: Gruppe: Motor - No. 3 Seite 2 17.08.1942

Betrifft: Abdichtung Nockenwellenbohrung hinten.

Re. Rear camshaft seal.

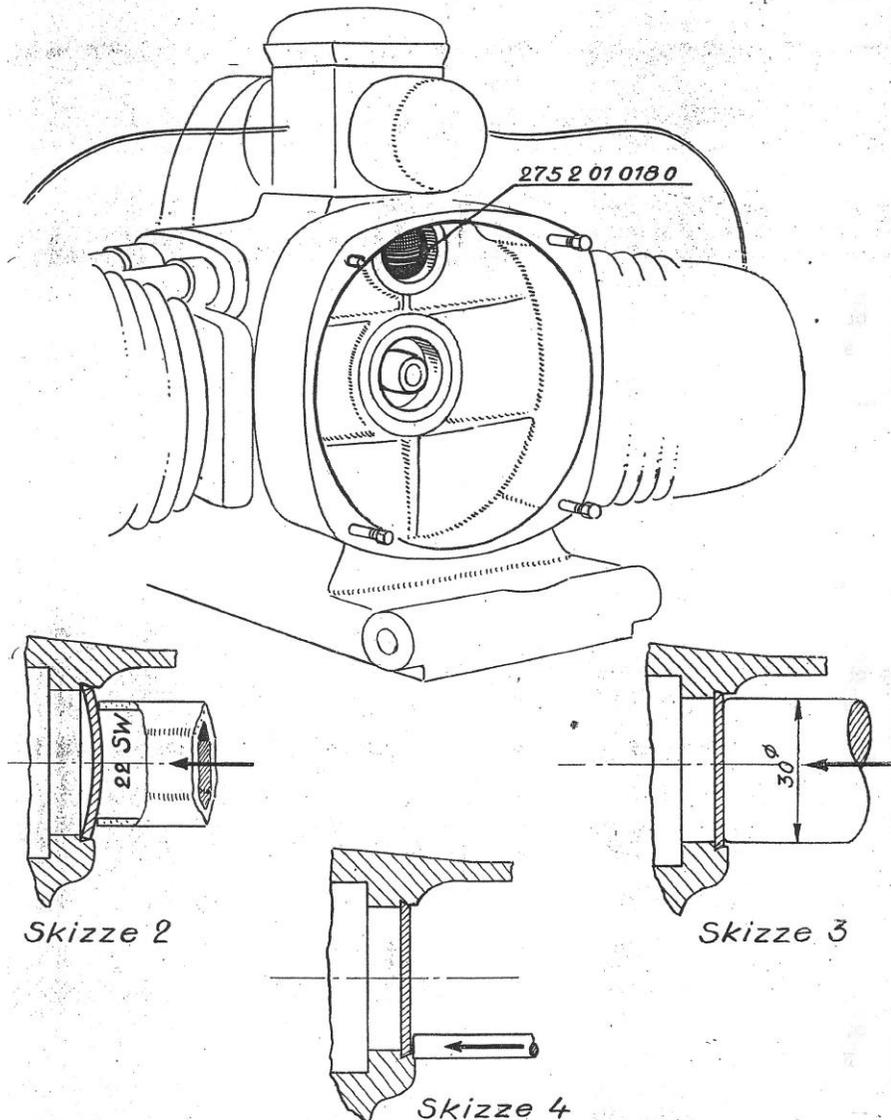
Skizze 1

Der Deckel ist gewölbt und seine Außenkanten sind schräg, damit er sich schön einspannen kann.

Der Deckel wird nun flach eingeschlagen, obwohl auf Seite 1 steht das dies auf keinen Fall sein darf.

Hier wird dann auch noch gezeigt wie das Verstemmen zu geschehen hat.

The lid is arched and its outer edges are sloping, so it can be nicely clamped.

The lid is now flat, although on page 1 this is not allowed to be.

Here is also shown how the caulking has to happen.
